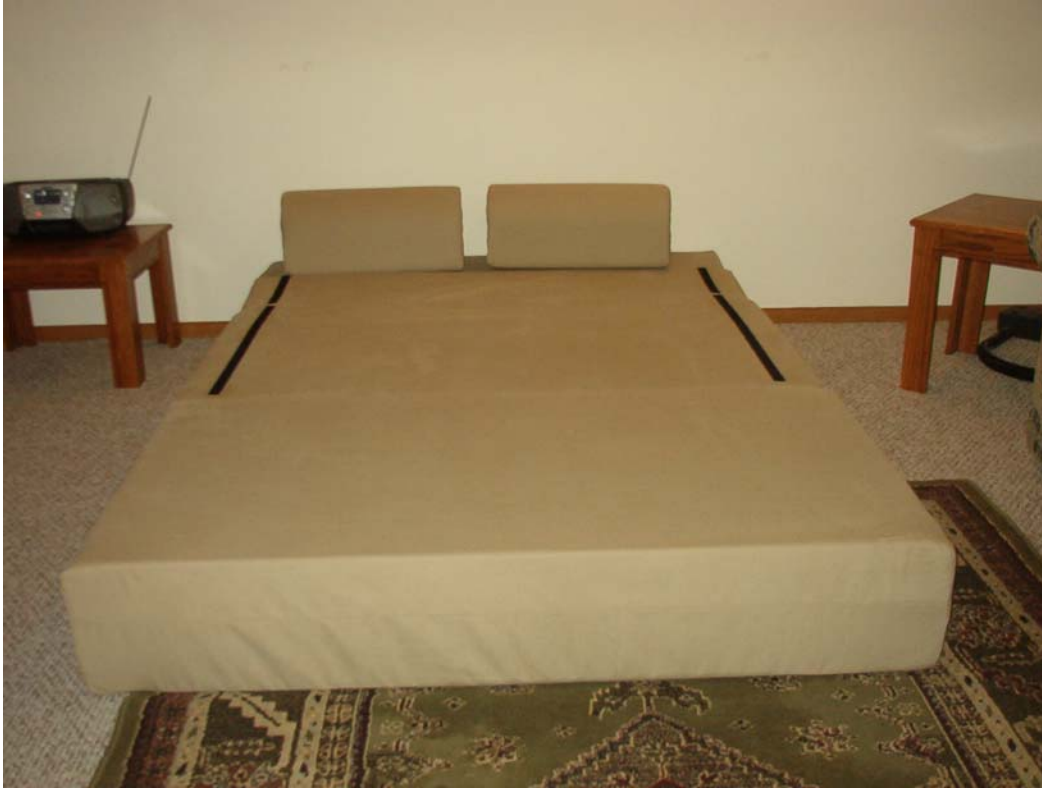
This couch was adapted for an individual who repeatedly sat on the arm rest of previous couches that invariably broke over time.

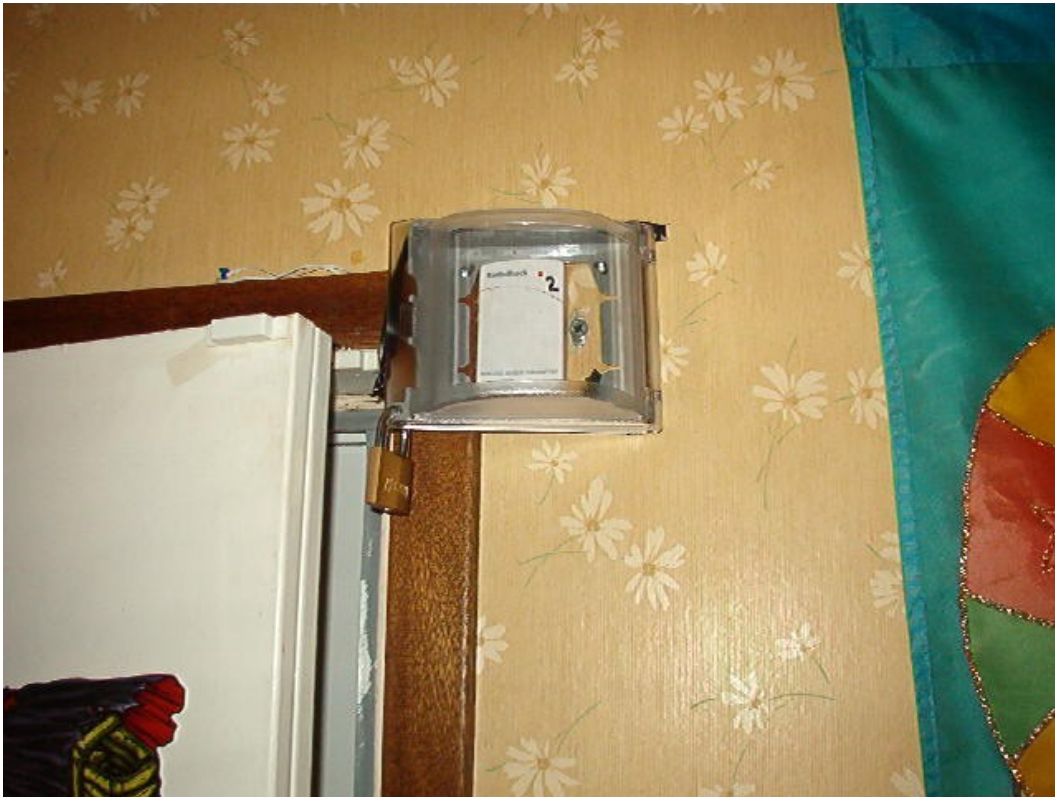
A plastic, locked covering was installed in this residence. The individual who lived here repeatedly tinkered with door alarms (pictured above) and thermostats (pictured below).

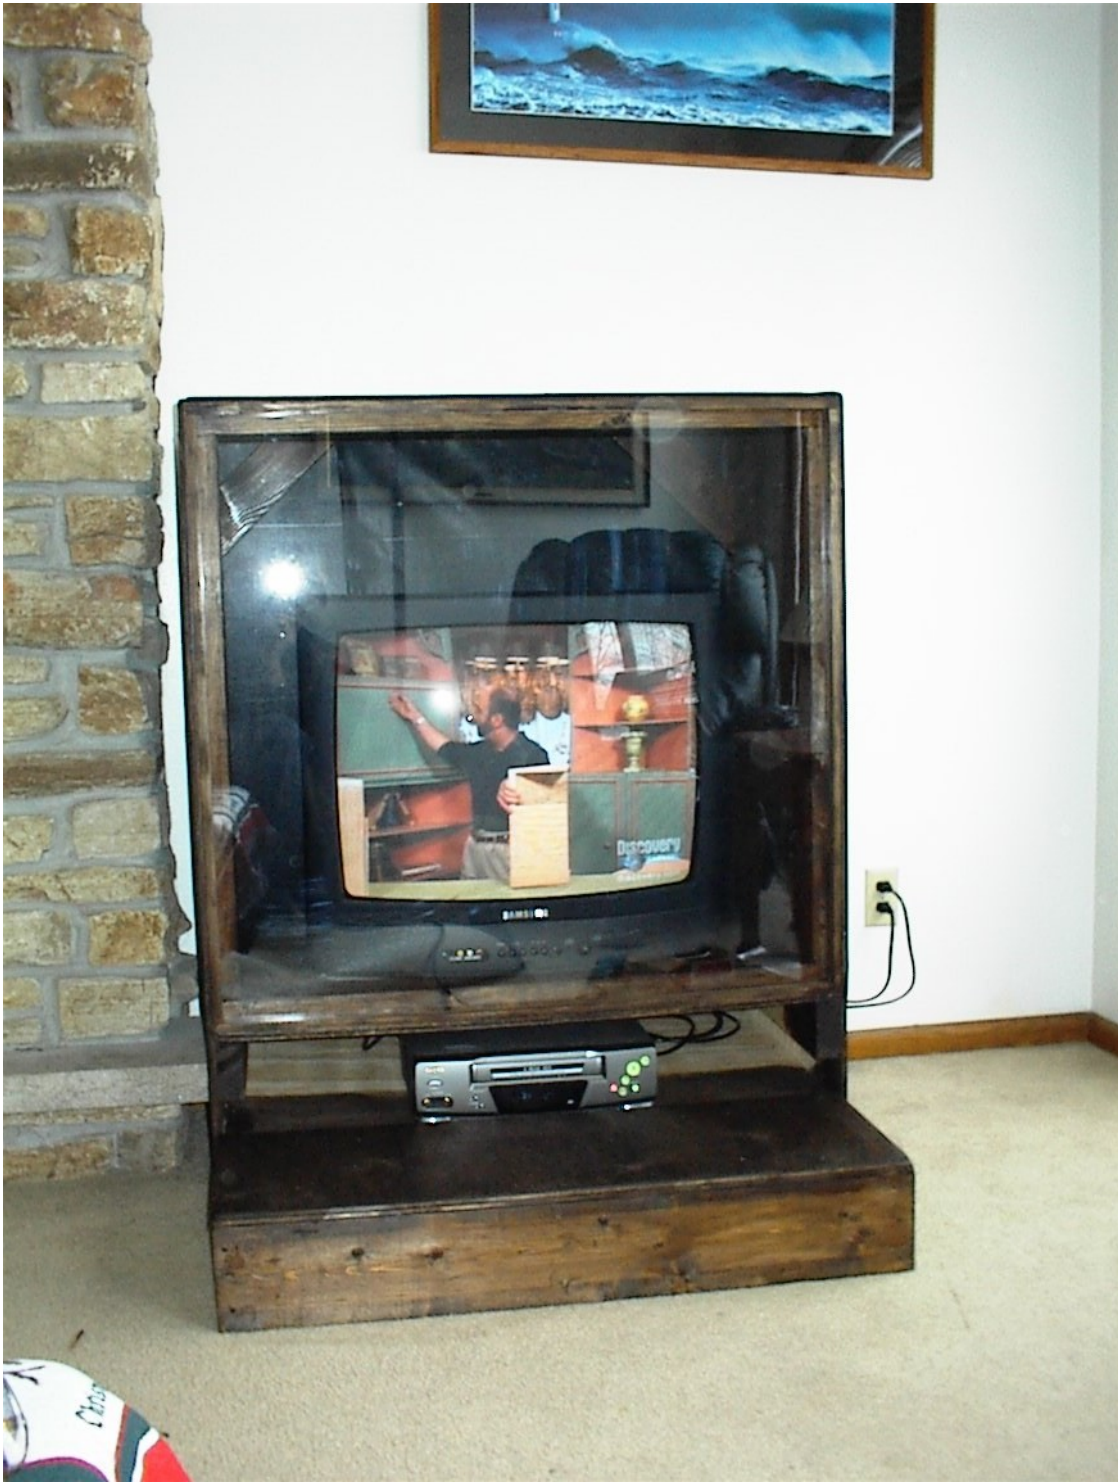
Below is a picture of an enclosed case used to protect the television.

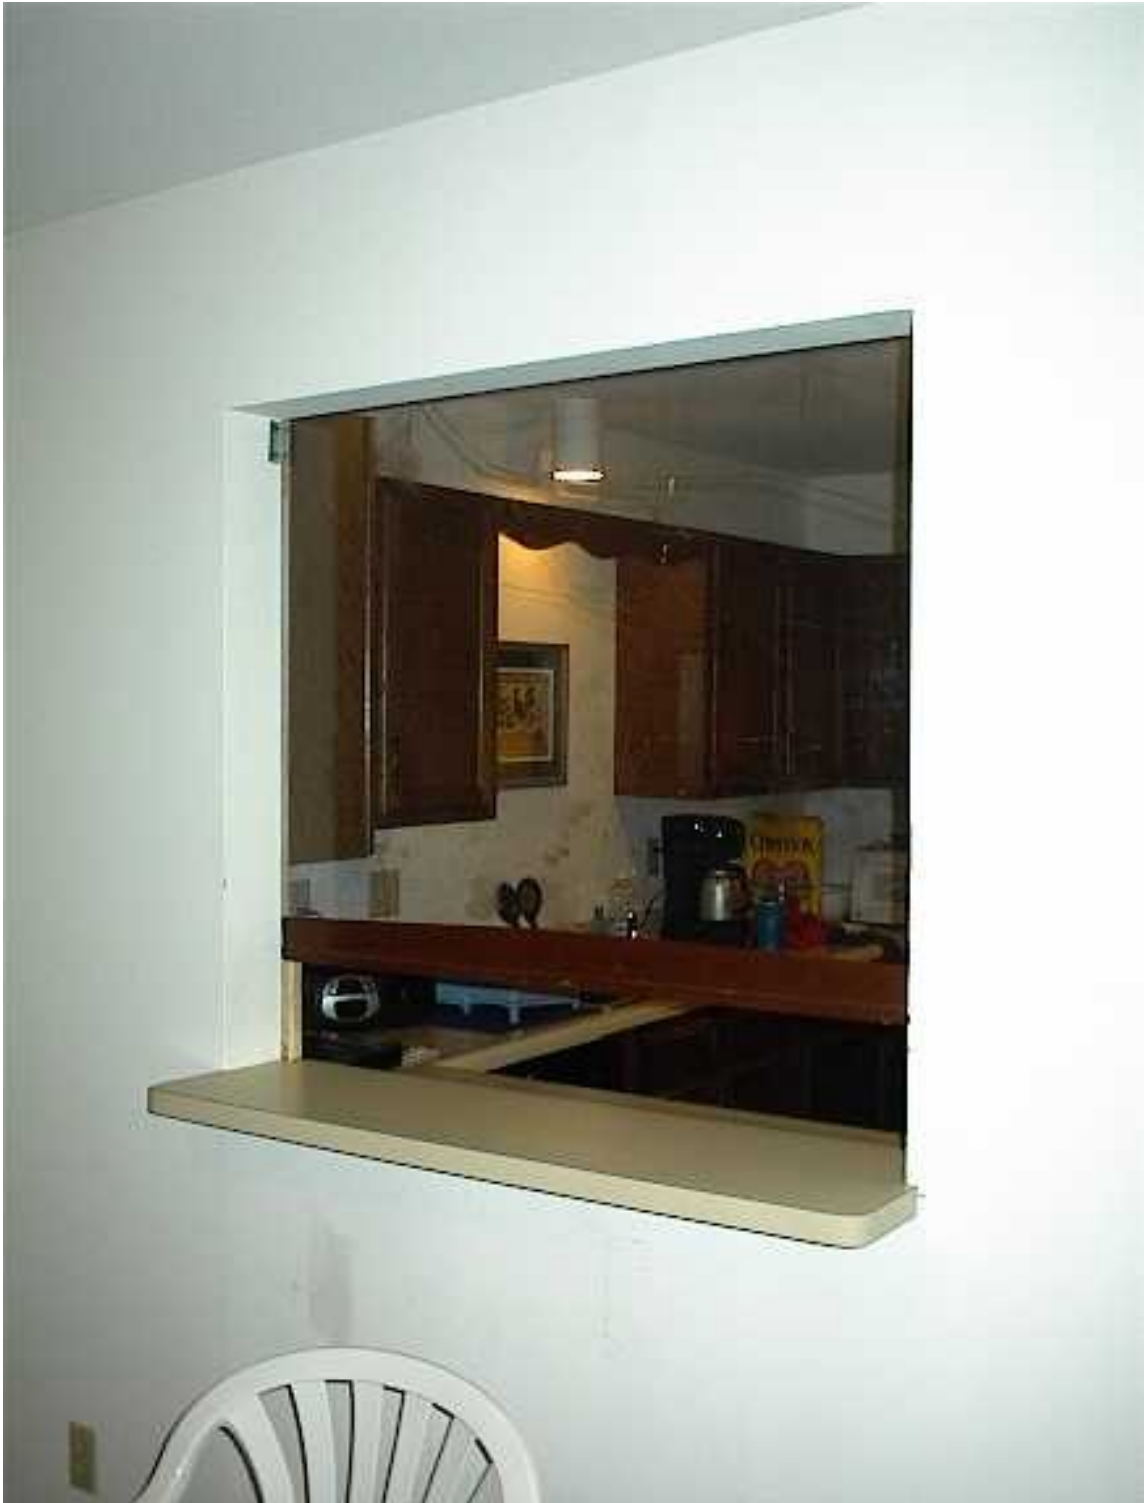
The picture of the kitchen window below was used in a home for an individual with Prader-Willi Syndrome. The window allowed the individual to see what was happening in the kitchen while limiting the person's ability to have access to the kitchen.

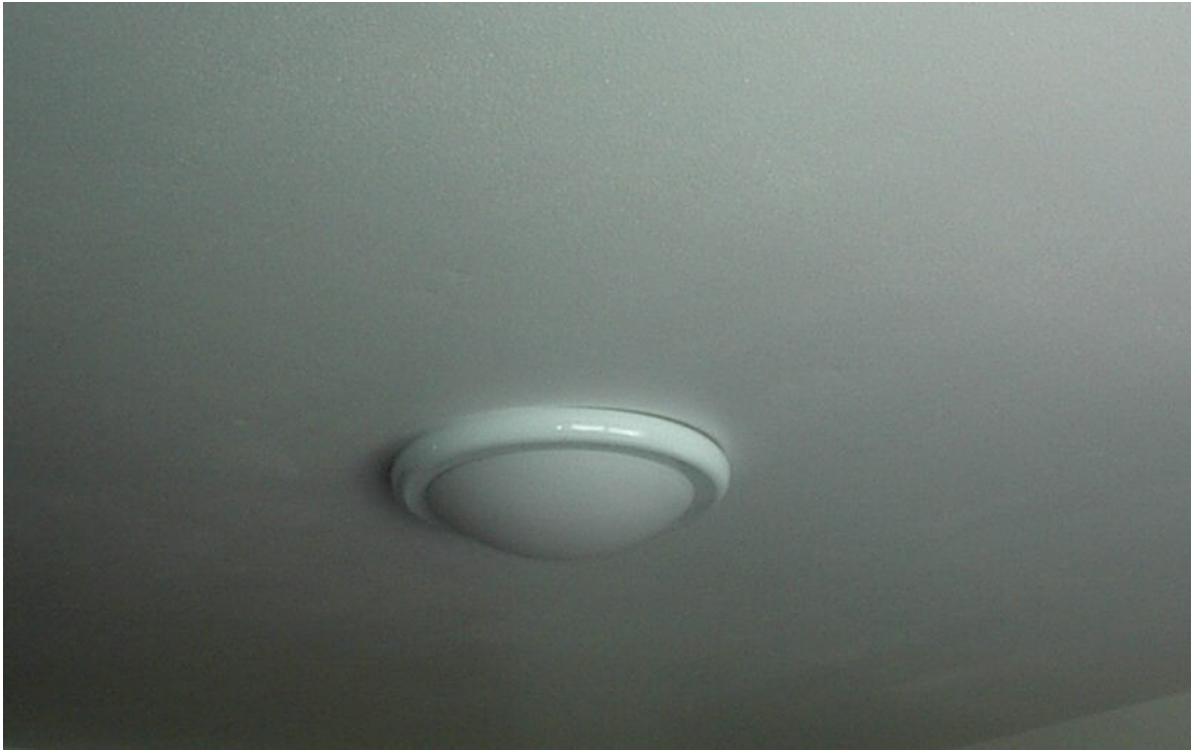
The final picture below is of a simple light fixture that replaced other overhead lights that were often destroyed. This fixture is made mostly of plastic preventing shards of broken glass from flying if someone attempted to break it.
